CASE STUDY: WEMBLEY

An invasive non-native species (INNS) remediation contract completed on a large complicated development site in Wembley, London. The works involved the treatment and removal of Japanese knotweed and Giant hogweed.

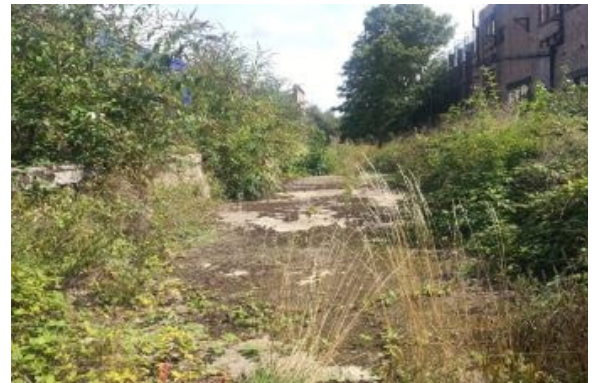
Our survey recorded active and chemically treated areas of Japanese knotweed to be 163m², with Giant hogweed totalling 9172, both of which were spread over wide, multiple areas of the site.

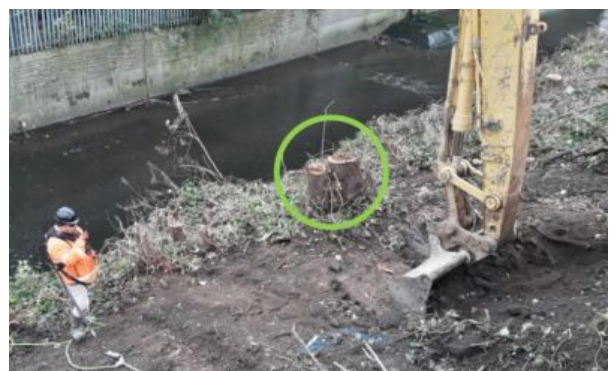
- Tree stumps and tree roots close to the River Brent wall needed to be left in situ, as removing them could affect the structural integrity of the river wall.
- Full depth excavation of knotweed rhizome along the river had the potential to destabilise the wall.
- The plant could not access within 25m of some affected areas adjacent to the riverbank. This limitation would need to be overcome.

A remedial method was needed that provided a practical solution to removing the INNS (Japanese knotweed and Giant hogweed) given these constraints. INNS in other areas of the site could be more easily accessed and fully removed using mechanical excavation. The survey also identified INNS on a small parcel of land which was inaccessible to machinery due to a copse of trees that were to be retained. As there were no planned ground disturbance works, we recommended continuing with a Herbicide Treatment Programme for long-term control.

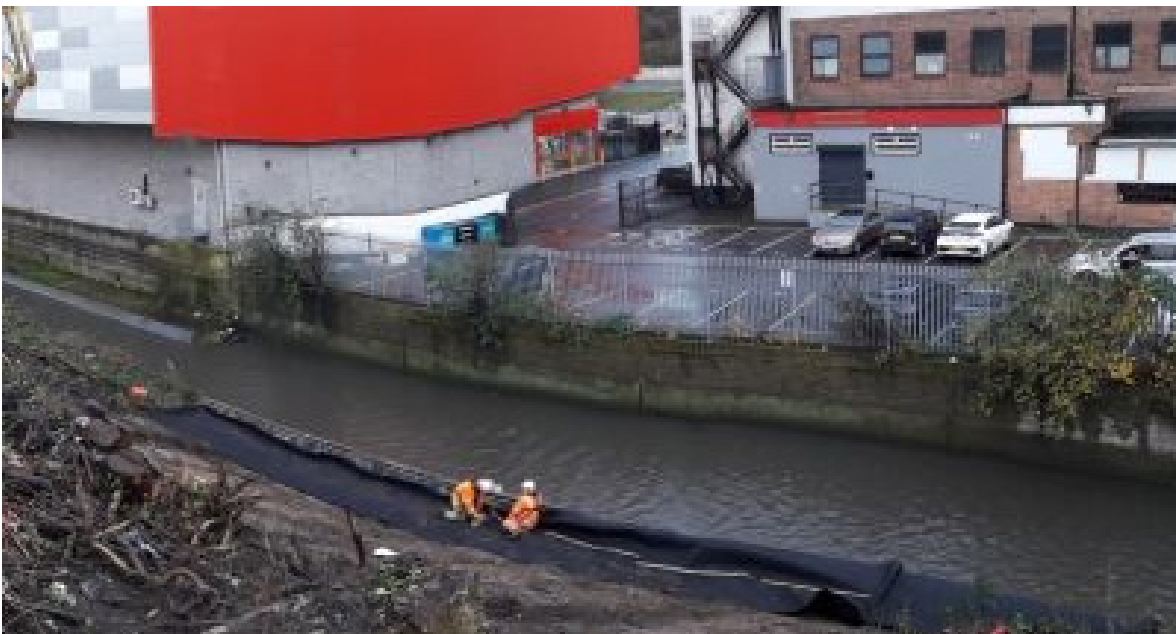
We implemented remediation methods that worked to the identified constraints. Specialist long-reach 38-tonne tracked excavators were used to provide the extended reach required to excavate down by the river wall. INNS impacted ground was removed away from the wall to an engineering depth deemed safe to maintain wall integrity.

Where engineering specification required a reduced depth excavation, horizontal and vertical root barriers were installed to cap remaining contaminated soils, with root barrier sealed back to the river wall.

All remaining knotweed contaminated ground was carefully excavated to remove the full depth and lateral spread of the plant's underground rhizome. This method provided an approved (PCA, Knotweed Code of Practice) instant eradication method for the plant and free unimpeded development use of the area on completion. The Giant hogweed contaminated ground was excavated to remove the plant's roots, tap-root and surrounding soils containing the plant's seeds.
