## CASE STUDY: RESIDENTIAL EXCAVATION

Survey and full excavation works to remove a large area of Japanese knotweed at the rear of a residential property, in addition to a small outbreak by the side of the house.

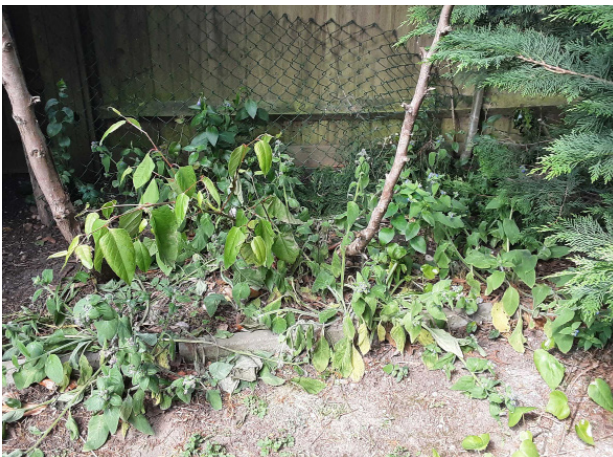
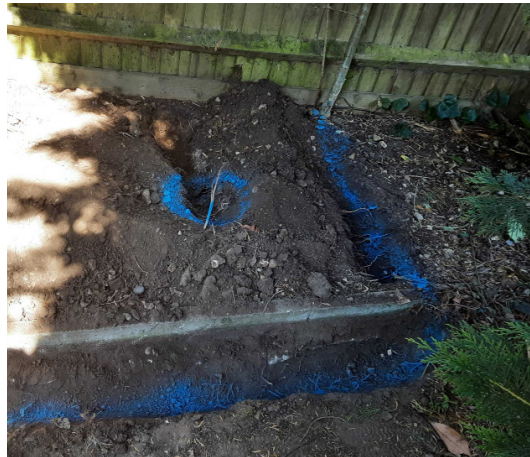
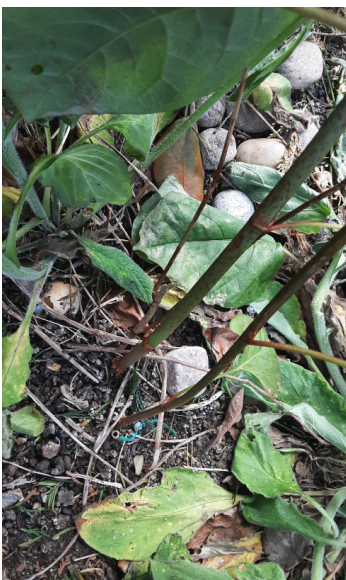
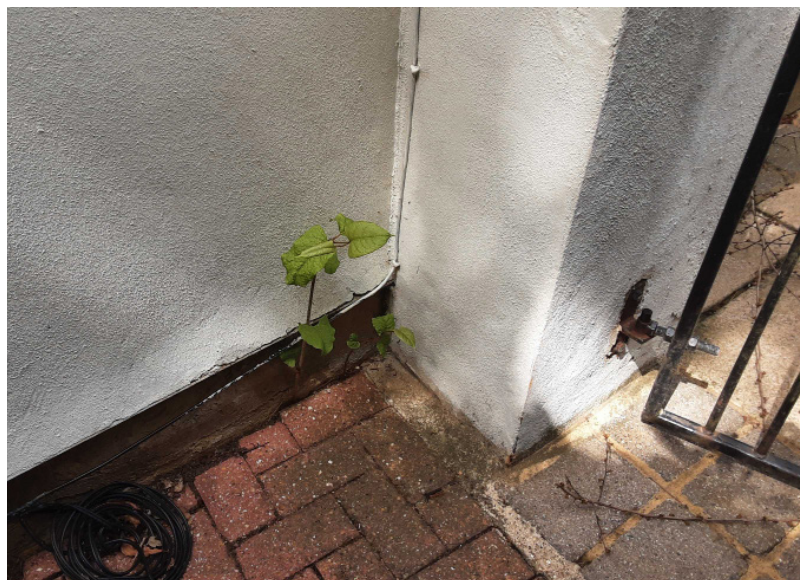
We were requested to carry out a survey on a residential property as Japanese knotweed was suspected. The survey established that knotweed was growing within both the front and rear gardens in three areas each covering approximately 1 square metre, however a further surrounding 3 metres would be 'at-risk' of knotweed growth due the underground rhizomes not visible above ground. Additionally knotweed was visibly growing in the neighbouring property, which would cause encroachment issues if allowed to penetrate the client's land.

Although one area of knotweed growth was within the hard landscape between the house and block paving, there were no visible signs of material damage to the property or any associated infrastructure (walls, paths or the driveway).

Over a period of three days, we completed full excavation to a depth of 1.3 metres with all waste being removed to landfill. A vertical root barrier was installed in one area at the boundary fence, and a horizontal root barrier returned vertically to the brickwork of the house. These barriers would ensure any potential fragments of rhizome would not be able to grow into new plants.

The knotweed affected area was backfilled with topsoil, and in one area backfilled with crushed concrete. The area offsite will continue to be treated under a herbicide treatment programme to ensure no further problems will occur in the future.
