JAPANESE KNOTWEED™ TO BE IGNORED

CASE STUDY: CELL BURIAL

Eradication of Japanese knotweed from a large site in Southampton, using on-site burial (cell-burial). The site also contained asbestos that required removing.

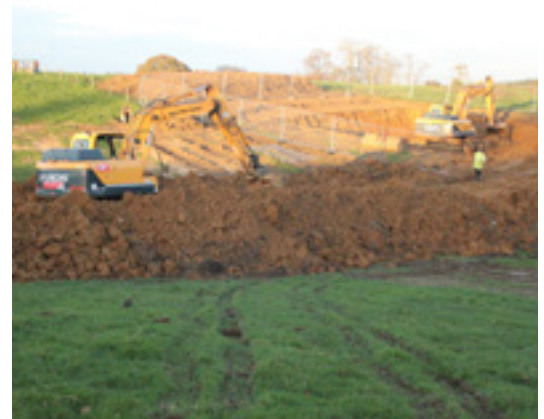
The base and flanks of the burial pit were lined with root barrier, with barrier joins completed using heated butyl seams by trained JKL staff. The base sheet was covered with a blinding to prevent puncturing. The bottom of the burial pit was filled with the excavated knotweed soils. The soils were installed into the pit in shallow layers with a sheep's-foot compaction roller used to compact each layer before another was added. This compaction will help avoid ground settlement on completion, which could have left a depression in the finished surface of the new park.

Before capping the cell, all plant was decontaminated, with arising from the cleaning added to the cell. A final root barrier capping sheet was added covering the knotweed soils and welded to the flanking sheets to form a complete encapsulation cell. Where knotweed rhizome was found transcending the boundary, vertical root barrier was installed to prevent potential future ingress of knotweed back into site.

The remaining void over the finished cell was backfilled with site won soils. The location, dimension and depth of the burial was recorded in JKL's completion report and provided to the client for inclusion in their operations and maintenance manuals for the site.
